X-ray radiographic analysis of the two wooden sculptures of 18th century

Azeredo, S. R.^a; Oliveira, R.^a; Gusmão, E.^b, Anjos, M.^c, Sanches, F.^c, Lopes, R. T.^a and Oliveira, D. F.^{a*}

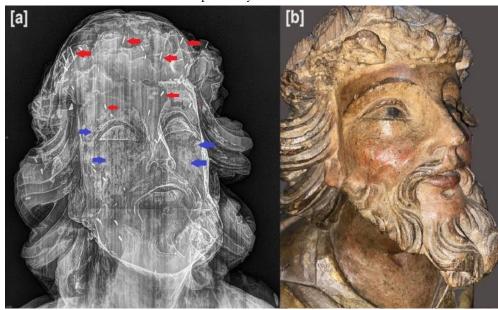
Figures 2-4 show results of the radiographic images analysis. In Figure 2-a, the radiographic image of the sculpture's head several denser areas are revealed (indicated by the red arrows). This suggests that, following the carving phase, the wood underwent a superficial filling using a denser material, possibly as part of the preparation for the painting of the artwork. It also shows the paint layer in the facial area, which is significantly deteriorated with some discontinuities in the paint.

Figure 2: [a] Radiographic image and [b] sculpture of the face of King David. The radiograph shows several points of higher density than the wood (red arrows) and the facial area where the deterioration of the paint layer is visible.

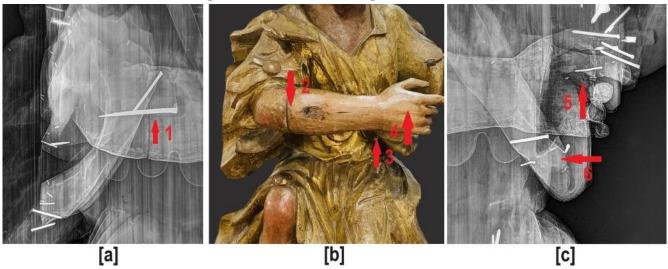
Figures 3-a and 3-b provide detailed radiographic images of the right arm (arrow 2 in Fig. 3-b). The radiographic image of this region shows that the artist used a metal nail for this joint (Fig. 3-a, arrow 1). In contrast, Fig. 3-c shows more modern nails, which were likely used during the restoration process to provide additional support to the right hand (indicated by arrows 5 and 6).

Figure 3: Radiographic analysis of the right arm of the King David sculpture. [a] image of a metal nail used by the author of the work to connect the forearm and image of restoration nails providing support to a part of the garment on the right side; [b] photograph of the right forearm of the sculpture; [c] radiograph showing restoration nails in the right hand of the work.

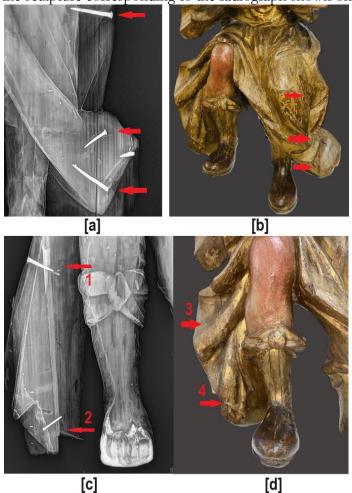
Figs. 4-a and 4-b show, respectively, metal nails used by the artist to connect a part of the clothing on the left side to the rest of the sculpture, indicating that the artist carved this part separately. Fig. 4-c presents the radiographic image of the lower part of the leg and clothing of the King David sculpture, indicating with arrow 1 an original support nail from the artwork and with arrow 2 a restoration nail. Fig. 4-d shows the photograph of the area where the nails are located, approximately (arrows 3 and 4).

Figure 4: [a] Radiographic image of the left side of the clothing of the King David sculpture, indicating the metal nails used by the artist; [b] photograph of the clothing area, showing the approximate location of these nails; [c] radiographic image of the right foot of the King David sculpture; and [d] photograph of the region of the sculpture corresponding to the radiograph shown on the right.

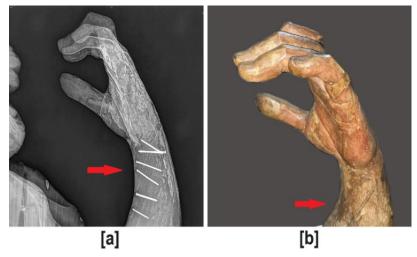
Fig. 5-a shows the radiograph identifying smaller restoration nails used by the restorers, indicating their concern for greater structural stability of the right hand, which might have been compromised due to probable wood deterioration. Fig. 5-b shows the approximate area where these nails are located. Radiographic images of the harp that forms part of the King David sculpture were also obtained, revealing restoration nails (Figs. 6-a to 6-c) and signs of paint coverage with some areas already deteriorated.

Figure 5: [a] Radiographic image of the left hand of the King David sculpture, indicating the nails used in the restoration of the artwork; and [b] photograph of the left hand area, showing the approximate location of the restoration nails.

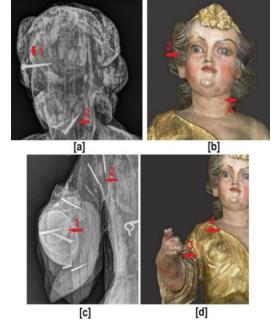
The same technique of creating the artwork, carving some parts separately from the main structure, was observed in the sculpture of the Bathsheba. Figures 7-a show radiografic image of the head, indicating two large nails to secure the face to the main part of the head and in Fig. 7-b, a photo indicating the approximate location of these two fastening nails.

In Fig. 7-c, there is also an indication of a nail for attaching the left forearm to the main structure and, in the trunk region, an external support for fixing the sculpture to the church wall. In the shoulder region, restoration nails are visible, providing support for the arm (Figure 7-d).

Figure 7: [a] Radiographic image of the head of the Bathsheba sculpture showing two metal nails used to connect the face to the head; [b] photograph of the head of the sculpture indicating the location of the nails with arrows 3 and 4; [c] radiographic image showing nails placed by the artist to connect the forearm to the sculpture (arrow 1) and two restoration nails from a later restoration (arrow 2); [d] photograph indicating the approximate locations of the nails and restoration nails with arrows 3 and 4, respectively.
