# **Compliance and quality control monitoring of diagnostic X-ray facilities in Dar es Salaam city, Tanzania**

**Leonid L. Nkuba<sup>1\*</sup> and Pendo B. Nyanda<sup>1</sup>**

<sup>1</sup>Tanzania Atomic Energy Commission, Radiation Control Directorate.  
P.O Box 80479 Dar es Salaam zonal office, Dar es Salaam, Tanzania

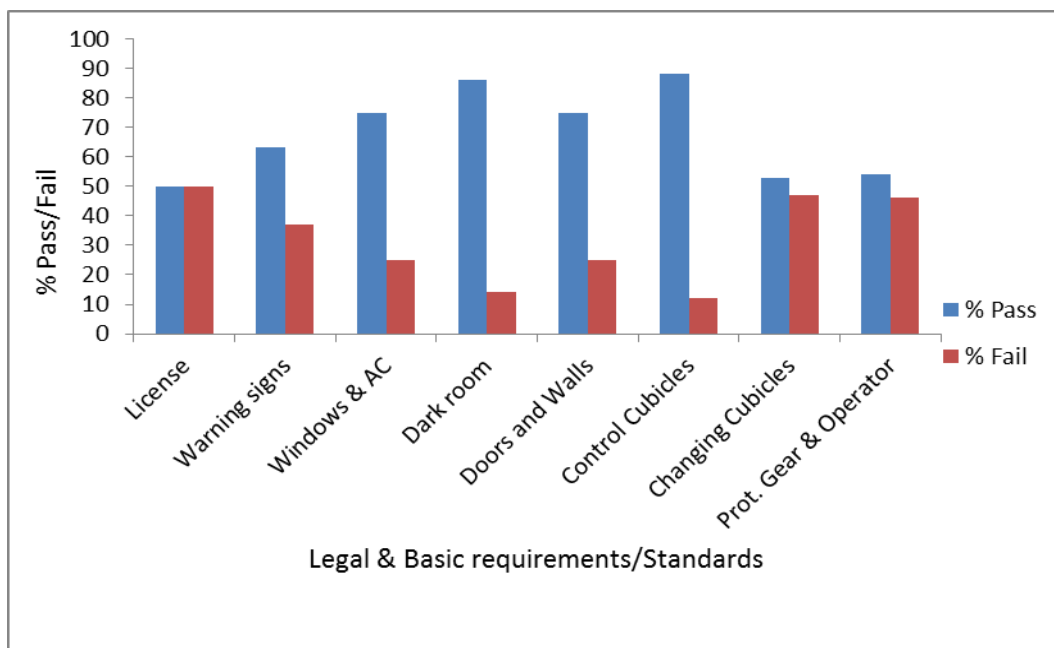
**Figure 3:** The assessment of Legal and Basic/ Standard requirements of the X-ray facility

The legal and basic requirements were assessed in term of pass or fail basing on criteria given in Table 3. As shown in Figure 3, the issue of license, changing cubicles, protective gears and qualifications of operator seems to be a problem in surveyed hospitals. The other criteria did not have many problems. Only one study in Tanzania reported on dark rooms quality. The assessment was based in terms of film fog, film storage and cleanliness. The results showed that about 70% of 400 X-ray dark room facilities were adequate [18]. However, awareness on the importance of these criteria in relation to radiation protection is needed.

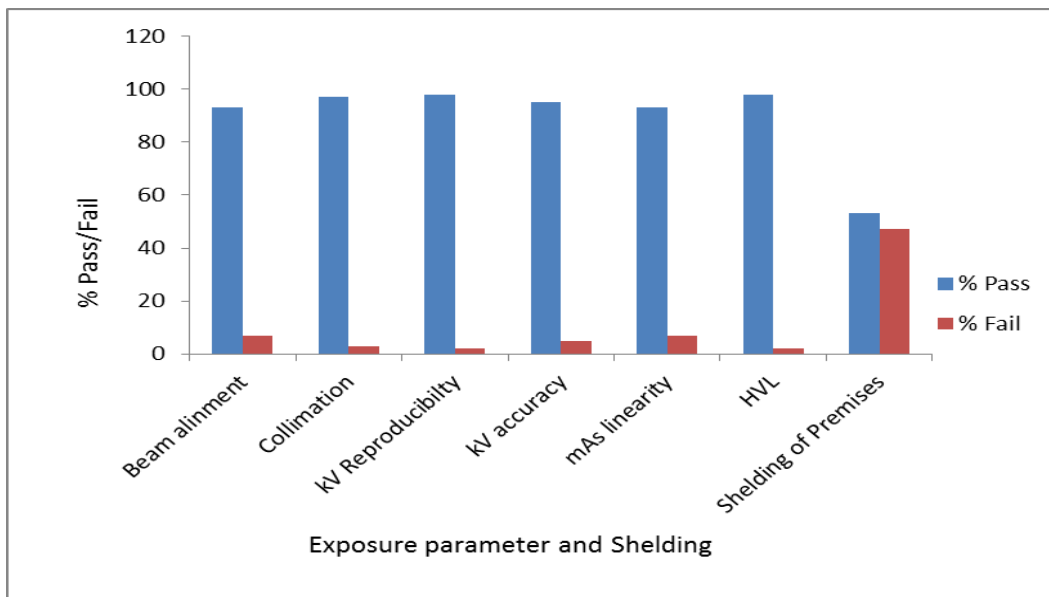
**Figure 4:** Evaluation of exposure parameter based on recommended limits

As shown in figure 4, the exposure parameter was in acceptable conditions as they were within the recommended limits. Only parameter that suffers from this study is shielding of the premises. The radiation leakage was observed 27 (47 %) of the assessed X-ray facilities, the problem was more observed at door (D1) leading to the X-ray rooms, in the changing and control cubicles and patients waiting areas. This was a result of poor shielding.
