Semiconductors (LEDs) quality control based in high-resolution 3D X-ray microscope

Keywords: Computed microtomography, Semiconductor integrity, LED microtomography.

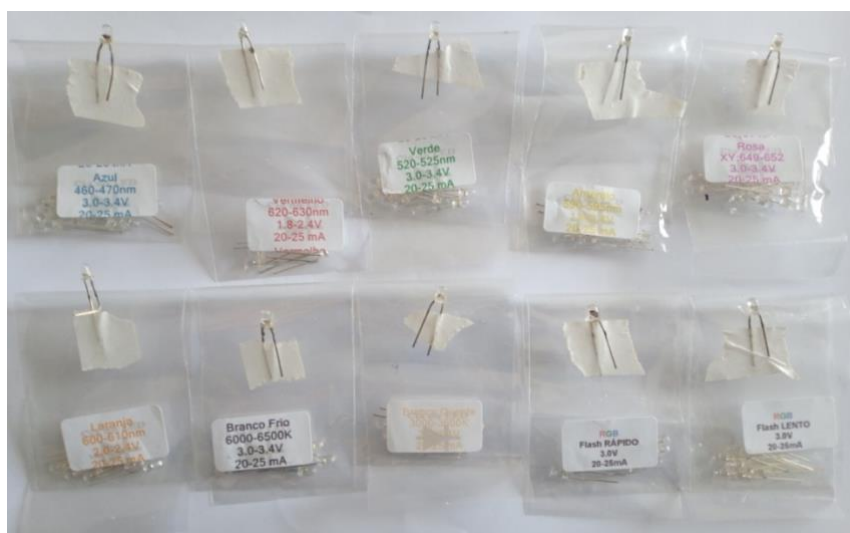
Figure 3: LED colors from top to bottom and left to right: blue, red, green, yellow, pink, orange, cool white, warm white, RGB fast flash and RGB slow flash.

A group containing several LEDs was analyzed (ten LEDs), however, due to the images similarity, was chosen a LED that emits light in the red wavelength to illustrate the results. Fig. 3 shows the set used as samples for analysis.

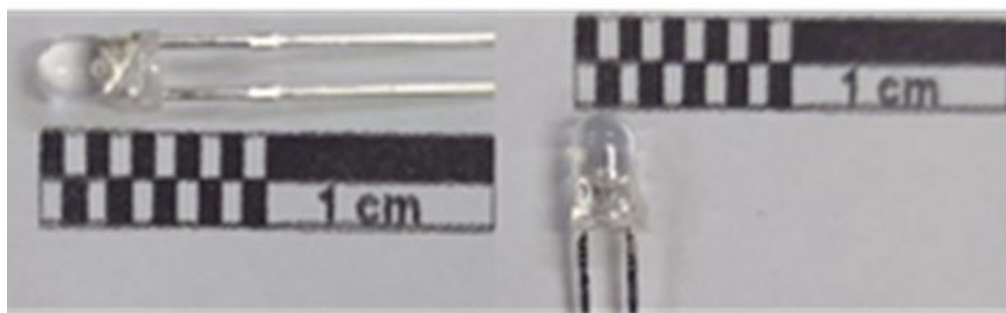
Figure 5: Utilized sample.
Source: The author

All samples have similar dimensional characteristics, therefore, due to this, one was taken to show dimensional characteristics (Fig. 5).

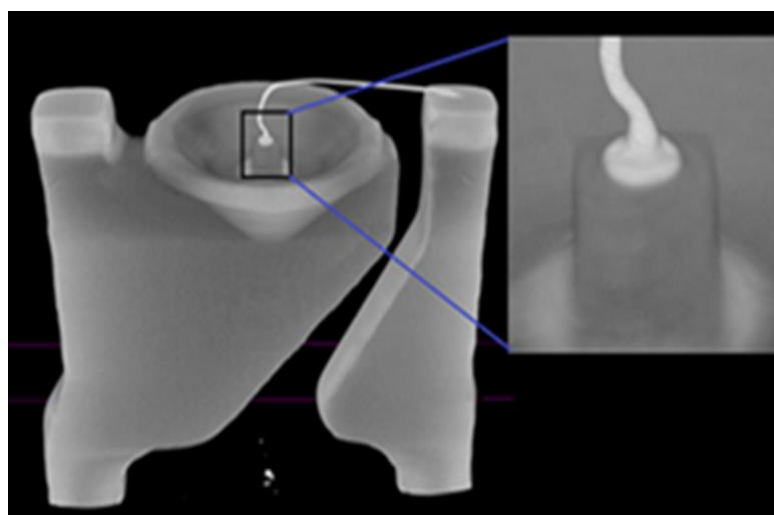
Figure 6: 3D red LED internal reconstruction before EOS.
Source: The author

Based on the projections made before EOS, and to exemplify the reconstruction processes applied to the red LED, the image at Fig. 6 was built to a better observation. It was possible to notice its entire internal structure, including the P-N junction in interior.

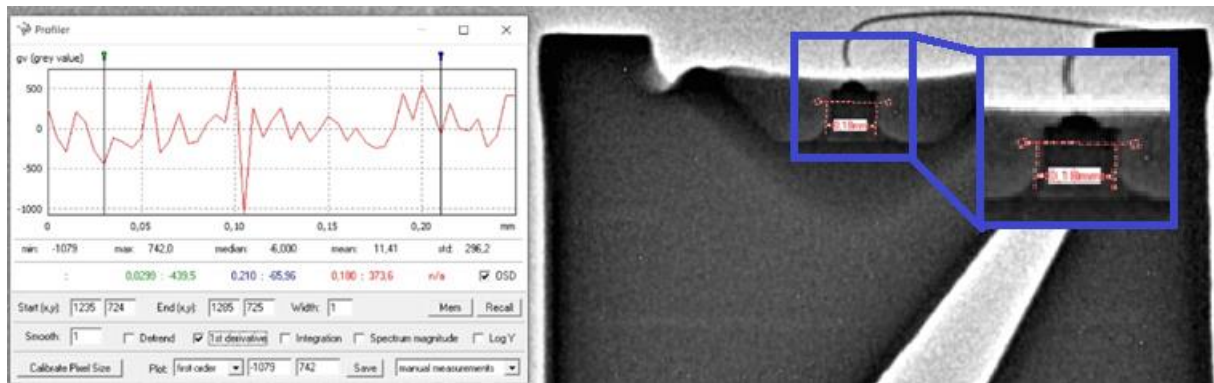
Figure 10: *Corrupted wire bond with greyscale of sample and dimension of P-N junction.*
Source: The author

The P-N junction was analyzed in both cases (when the set of LEDs were corrupted and not corrupted by electrical overstress). Visually and metrically was possible to notice there was no difference. The Fig. 9 and Fig. 10 shows the measurement process applied in a Red LED.

Some of the height measurements at the PN junction (z axis) do not match due to the fact that, upon electrical overstress, the wire bond inside is overheated and melts, where material accumulates on the P-N junction surface. This accumulation is distributed over the entire surface, giving the impression that the joint is higher.

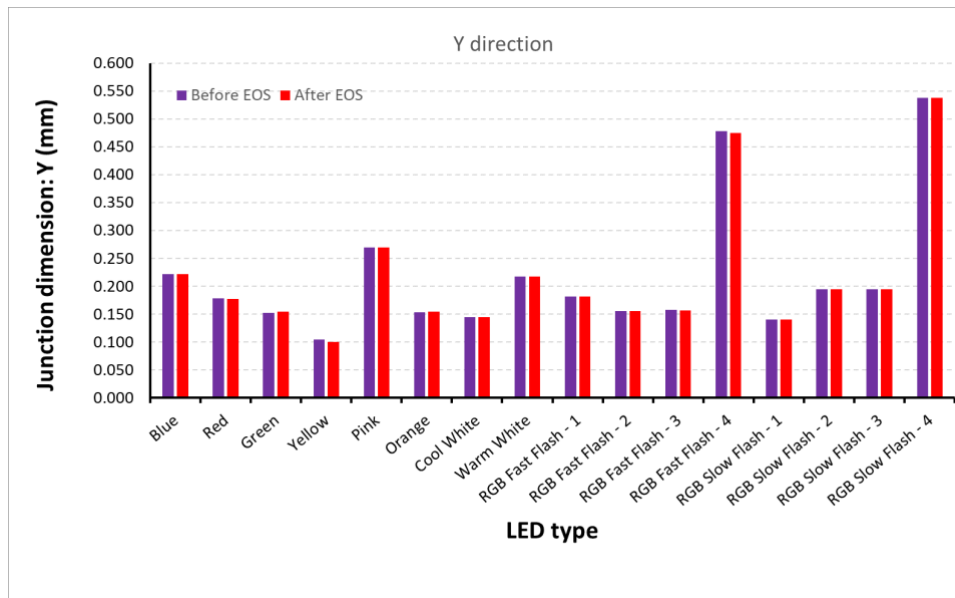
Figure 12: Measurements averages Comparison at Y direction.
Source: The author

Figures 11-13 comparatively show the mean values of the LED's P-N junction dimensions in a bar graph. It performs a visual comparison between size averages measurements at the three directions (x, y and z) with the situations before and after electrical overstress. The measurements indicated on the vertical axis of this graph are in millimeters.
