# Decommissioning and demolition of a dicalcium phosphate plant: aspects of radiological protection and safety

**Abstract:** The detection of ionising radiation in materials from the decommissioning of a dicalcium phosphate plant meant that this whole operation had to be overhauled in terms of radiological protection and safety. Thus, an operations plan was drawn up that included: initial training for all workers involved, measurements of dose rates and a set of analyses by gamma and alpha spectrometry. Samples of "dry sludge" and debris were analysed for the identification and quantification of the radionuclides present, samples of workers' urine were analysed for the detection of any internal contamination, samples of washing water and air filters were analysed for the detection and control of any radioactive atmospheric contamination. In addition, individual dosimeters were distributed to workers. The extent of contamination was identified and the areas where higher values were detected were properly marked. From the results obtained (radiation dose rates and activity concentrations), it was possible to establish categories and separate the contaminated materials according to t

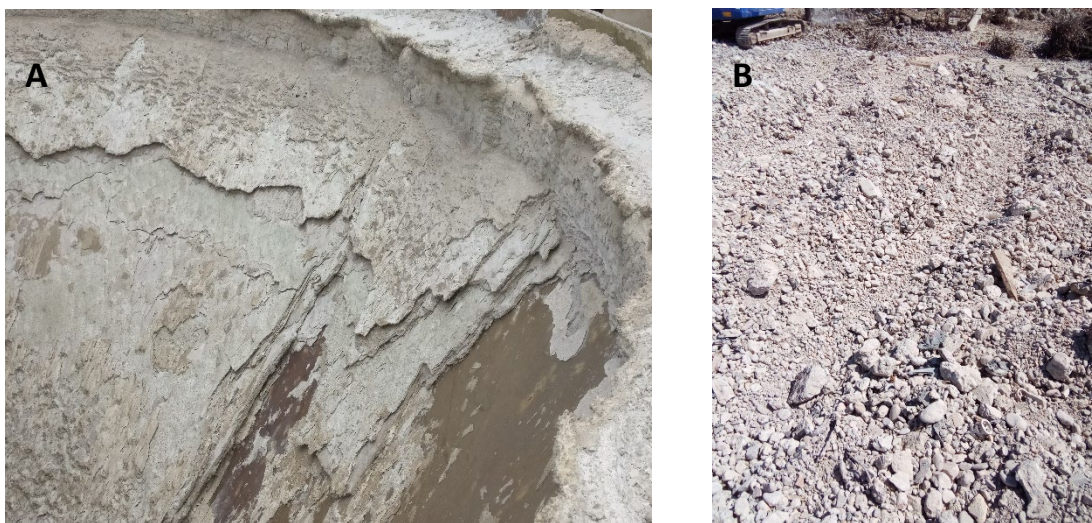
**Figure 1:** Dried sludge in reactor (A) and debris (B) for composite sample

In the on-site monitoring, it was verified that the radiation originated from the radioactivity existing in a kind of light-coloured "dry sludge" deposited over the years on the walls of the reactors, which are integral parts of the phosphate production chain, and which was dispersed.

All materials resulting from the demolition of the factory (Figure 1) were packed in duly numbered *big bags*. Around each *big bag*, a set of points was defined to measure the dose rates of ionizing radiation upon contact, with 10 values being recorded for each of these points. The measurements were made on contact because the objective was to relate doses with activities in order to apply the exemption and clearance criteria defined by the Portuguese Environment Agency. After recording the values, the maximum and minimum values were noted, and the arithmetic mean of the dose rates was calculated, as well as the respective standard deviation.

Regarding the different types of debris (concrete and brick), composite samples were collected at various points of the work and analysed. PVC samples were also taken from the reactors for spectrometric analysis.

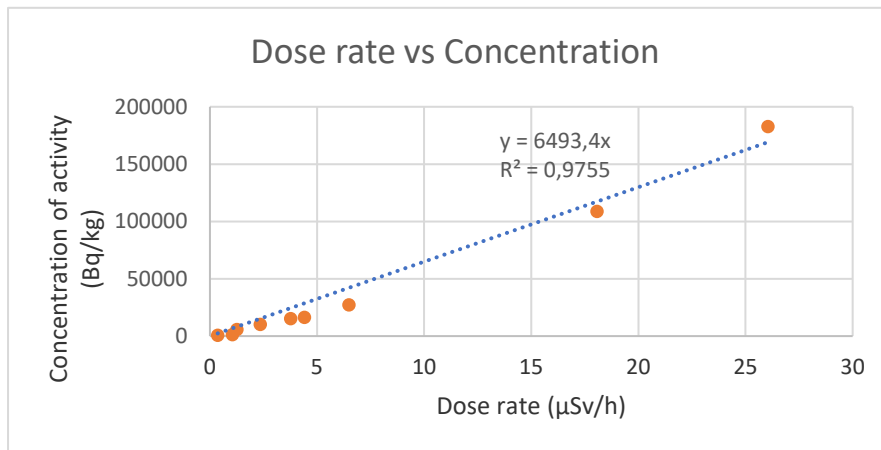
Figure 2 relates the dose rate values measured with portable equipment and the activity concentration in previously chosen *big bags*, calculated by gamma spectrometry in an accredited laboratory.

**Figure 2:** Correlation between dose rates and activity concentration of the *big bags*.

From the equation  $y = 6493,4 x$ , where  $x$  is the mean dose rate in the *big bag* and  $y$  is its activity concentration, the activity of all the *big bags* in the work was estimated.

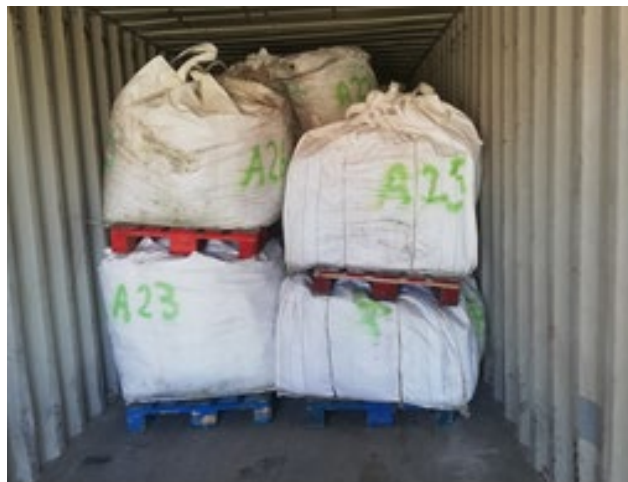
**Figure 3:** *Big Bags*. packed in a metal container.

Of the 103 existing *big bags*, some 41 could be excluded from regulatory control using the exemption and release criteria. The rest were packed in 2 metal containers of 30" (9 m) and 40" (12 m). These *big bags* are awaiting a final decision on their storage.
