# Assessment of Natural Radioactivity in a Residence in Belo Horizonte

**Abstract:** Natural radioactivity comes from natural radionuclides present in rocks and soil and from cosmic rays. In addition to gamma-emitting radionuclides, radon stands out, which is a carcinogenic gas. In nature, radon occurs as radioisotopes: <sup>222</sup>Rn (half-life time,  $t_{1/2}$ , of 3.83 d), <sup>219</sup>Rn ( $t_{1/2} = 3.92$  s) and <sup>220</sup>Rn (or thoron,  $t_{1/2} = 54.5$  s). The World Health Organization (OMS) recommends that it be measured in homes, with the recommended limit being 100 Bq/m<sup>3</sup> and the maximum limit being 300 Bq/m<sup>3</sup>. This work evaluates the origin of natural radiation in a residence in Belo Horizonte, Minas Gerais, Brazil, in which was observed radon concentrations above the limits established by the OMS. The detectors used were: nuclear trace detectors type CR-39, electrets (E-PERM), AlphaGUARD (AG) and the detector RS-230. The result of the <sup>222</sup>Rn concentration measured in the electrets in the rooms of the residence varied from 14,8 Bq/m<sup>3</sup> to 932 Bq/m<sup>3</sup>. At this highest point, the result of the average concentration

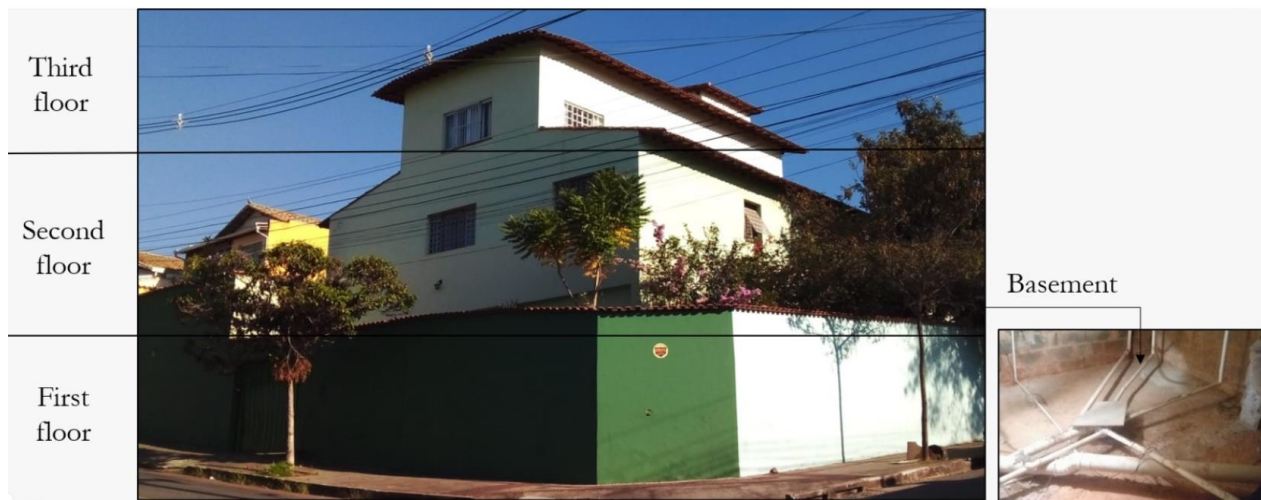
The study residence is located in the West Region of Belo Horizonte, Minas Gerais, Brazil (BH). That residence voluntarily was registered in the “Indoor Environment Monitoring Campaign – Belo Horizonte”, a campaign promoted by the Natural Radioactivity Laboratory of the Nuclear Technology Development Center (LRN/CDTN), also located in Belo Horizonte. The campaign was carried out by installing CR-39 nuclear trace detectors (a passive detector) in volunteer homes for a minimum period of 3 months and during two distinct seasonal seasons. The residence of this study was identified as one of the 2.8% that had a radon concentration above 300 Bq/m<sup>3</sup>; so, it was selected for this research. The CR-39 detector installed in that residence was placed in a bedroom on the first floor, located next to a basement, since the house was built partly supported on the ground and partly suspended. During the exposure time - 3 months in the dry period and 3 months in the rainy period - the radon concentrations were 445.0 Bq/m<sup>3</sup> and 231.2 Bq/m<sup>3</sup>, respectively. The most studied room in the residence was the semi-suspended basement located between the first floor/ground floor and the second floor. It has 3.0 m x 2.0 m in area and 1.5 m in height.

The basement entrance is inside a bedroom. It should be noted that the room does not have any ventilation or air outlet other than a small door measuring approximately 1.0 m x 0.6 m. Previous study [6], using electrets, have already indicated that in the basement of this same residence the value of  $159.1 \pm 7.4 \text{ Bq/m}^3$  was recorded.

**Figure 1:** Residence object of the study

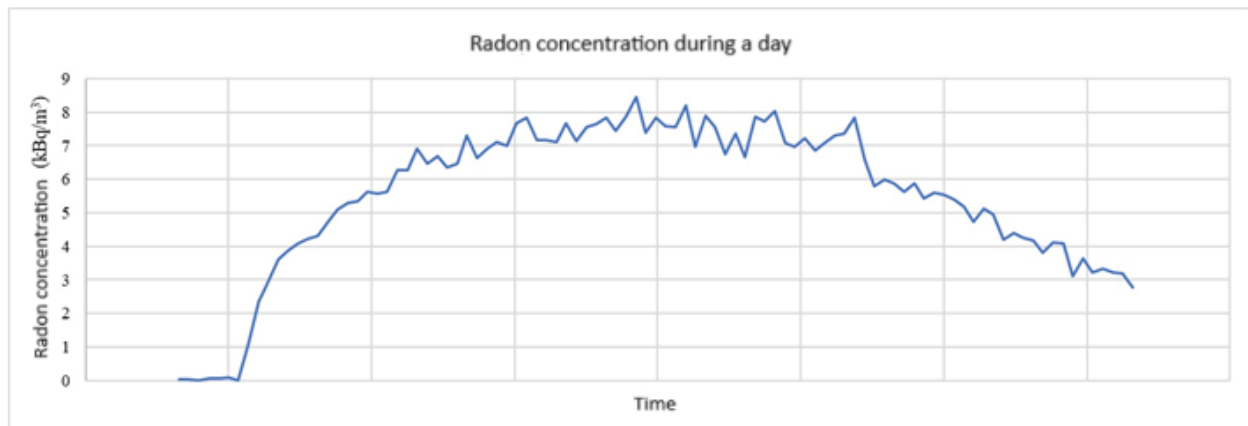
Radon monitoring with a continuous detector, AlphaGUARD<sup>®</sup>, is shown in Fig. 2. The maximum value recorded was 8448 Bq/m<sup>3</sup>. After 24 hours the room was opened and the radon concentration decreased. According to NN. CNEN (2014), the maximum value in a work environment such as underground mines should be 1000 Bq/m<sup>3</sup>. Therefore, as it is a room in a residence (even if unusable), it is a high value to consider carrying out mitigation measures, since radon can spread to the next room as well as to other areas of the house.

**Figure 2:** Radon monitoring curve by the AG continuous detector.

The evaluation of the radioactive gas radon was carried out with the AlphaGUARD<sup>®</sup> (AG), model PQ2000Pro, from Genitron (continuous detector), which is an ionization chamber, in diffusion mode, acting as a passive detector. The radon in the environment diffuses through a large surface glass fiber filter into the ionization chamber. As the basement had a higher concentration of radon, a measurement was taken with the AG detector. The room remained closed and without ventilation and the monitoring lasted approximately 24 hours, logging data every 10 minutes. Detector data were read into the (DataExpert software).

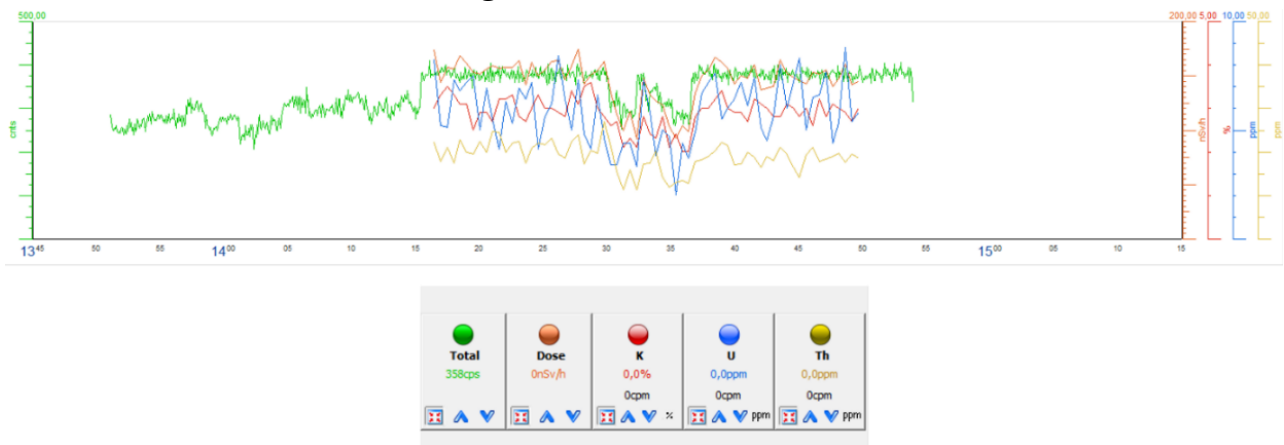
The results of the gamma scan with the RS-230, Figure 3, indicate higher counts on the uncoated walls. The number of uranium, thorium and potassium counts was low, without showing any anomalies.

**Figure 3 - Gamma scan result.**

The measurement of gamma radiation from uranium, thorium and potassium was performed with the RS-230<sup>®</sup> detector (Radiation Solutions Inc.), by scanning.
