# **Compliance and quality control monitoring of diagnostic X-ray facilities in Dar es Salaam city, Tanzania**

**Leonid L. Nkuba<sup>1\*</sup> and Pendo B. Nyanda<sup>1</sup>**

<sup>1</sup>Tanzania Atomic Energy Commission, Radiation Control Directorate.  
P.O Box 80479 Dar es Salaam zonal office, Dar es Salaam, Tanzania

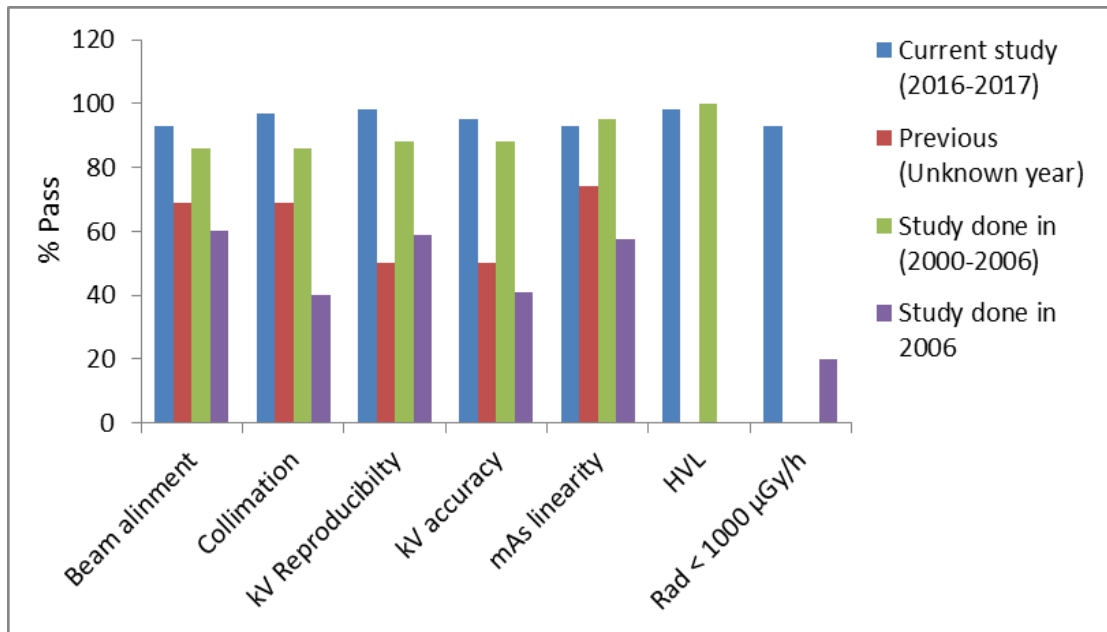
**Figure 5:** Comparison of % Pass in QC tests in Tanzania

As shown in figure 5, without regarding the number of equipment test, the results from this study seems to be good when compared to previous results of X-ray units evaluated in Tanzania. The results shows that, for beam alignment test 69 %, 86 % and 60 % in 22, 400 and 80 units tested pass the test [18-20]. In the area of beam collimation the same trend was observed. For kV (accuracy and reproducibility) tests, 50 % and 88 % in 16 and 400 units tested were declared as pass [ 18, 19], whilst 59 % and 41 % in 120 units test were declared as pass [20]. All the tested 400 units had

acceptable results of HVL ( $\geq 2.3$  mm Al) [18]. Radiation leakage test shows that, 100 % and 19.9 % in 2 and 47 units test passed the test. In the reviewed literature in this study, in Tanzania, out of 57 X-ray unit tested, 36.8 % did not qualify and the reason for this failure was the age of the equipment. Most of the equipment were more than 15 years old [19]. Also the issue of age of equipment was also a problem in Serbia and in Thailand as well [1, 21].

The good performance of most X-ray units evaluated in this study were largely attributed to installation of new X-ray machines in both public and private health facilities, this project started in 2006. In view of the above, it is evident that studies done from 2006 shows that most X-ray machines were within the recommended tolerance limits and hence optimum equipment performance. The results shows that the radiation protection of workers and patients has improved compared to previous years. The reasons for the improvement are enactment of the atomic energy act of 2003 and its regulations increased the number of compliances, also the installation of new X-ray machine in hospitals (especial government hospitals) through a joint project between the governments of Tanzania and the Netherlands [18]
