Quality control of Cone Beam Computed Tomography (CBCT) equipment used in dental applications according to RDC 611

Rocha ^{a,b*}, R. A.; Lisboa ^b, B. F. O.; da Rosa ^b, L. A. R.; Canevaro ^b, L. V.

^a Hospital da Força Aérea do Galeão (HFAG), 21.941-353, Rio de Janeiro, Rio de Janeiro, Brazil.

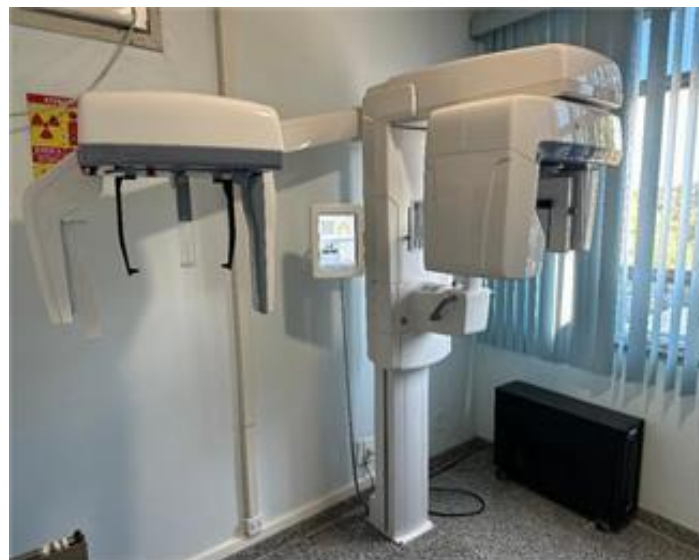
The present study was developed in the dental radiology department of the Galeão Air Force Hospital (HFAG), located in Rio de Janeiro. The dental radiology department is equipped with 12 intraoral radiography devices, distributed across 12 consultation rooms, in addition to an Instrumentarium cone beam tomograph model Orthopantomograph OP300 (Figure 1).

Figure 1: Instrumentarium's Orthopantomograph OP300

In addition to tomography, the device also allows for panoramic and cephalometric examinations, depending on the operator's initial selection. Despite being multifunctional, only the tomographic modality was evaluated in this study. The tomograph uses an X-ray tube with a nominal voltage of 90 kV. Parameters such as field of view (FOV - 3D area captured

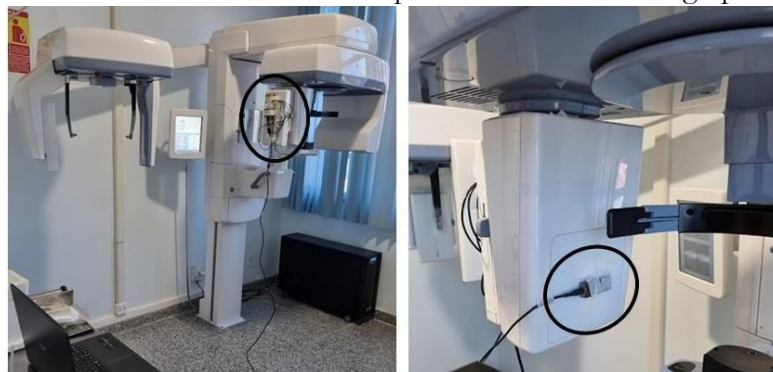
The parameters related to the equipment's X-ray tube were evaluated using a Radcal Accu-Gold AGMS-D solid-state detector connected to a digitizer, which transmits the information to a computer (Figure 2).

Figure 2: Detector Accu Gold AGMS-D positioned on the tomograph image receptor

Once the detector is multiparametric, the parameters as voltage accuracy and its reproducibility, exposure time accuracy and its reproducibility, and half-value layer were evaluated in a single exposure. Six exposures were performed for the same program suggested by the equipment (which offered the longest exposure time — FOV 61 x 78 mm², current 6.3 mA, and 13 seconds of exposure time).

The parameters dose indicator accuracy and air kerma rate accuracy were analyzed using the Accu-Gold AGMS-D solid-state detector placed in the center of the CBCT equipment's imaging detector.

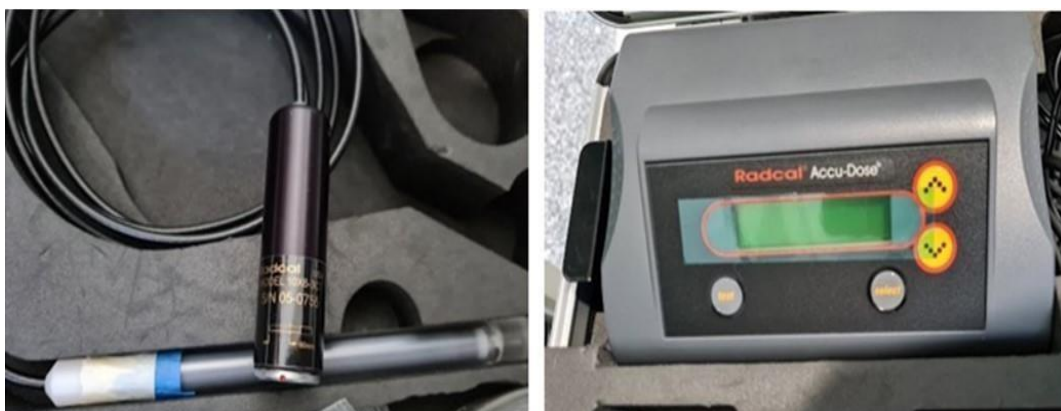
P_{KA} values were determined using a pencil-type ionization chamber, manufactured by Radcal, model 10X6-3CT, paired with an electrometer (Accu Dose 9095). This pencil-type ionization chamber was placed in the center of the image detector. An image plate (IP) from a CR radiography system was used to determine the actual field size, (i.e. area = length, b multiplied by height, h) employed during irradiations. Figures 3 and 4 illustrate the experimental setup. From the air kerma measurement, the kerma-length product was calculated using equation 3 (length of the chamber = 10 cm) and from this P_{KL} value, using equation 4, the P_{KA} value was calculated.

Figure 3: Ionization chamber and electrometer

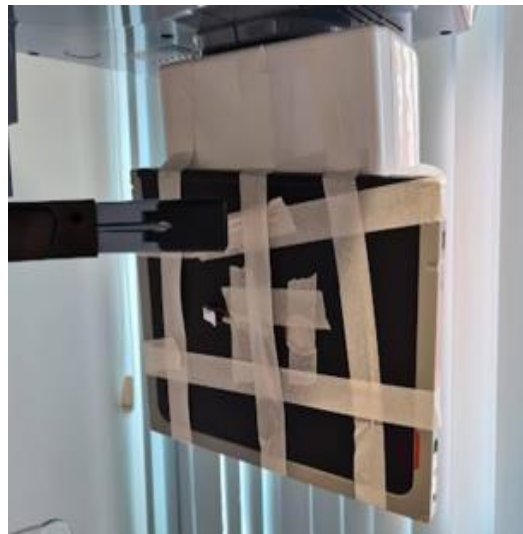
Figure 4: IP positioned on the image receptor to determine the field size used on irradiation

The height of the radiation field (h) was measured with a cassette used in computed radiography (CR) positioned at the detector entrance, yielding a result of (10.3 ± 0.1) cm. A radiopaque object was used as a reference to correct the image magnification effect. The field size was measured with a calibrated ruler in centimeters with a precision of 1 mm. According to the manufacturer's manual, the image detector area is 100 x 68.2 mm, confirming that the radiation field is confined to the device's detector.

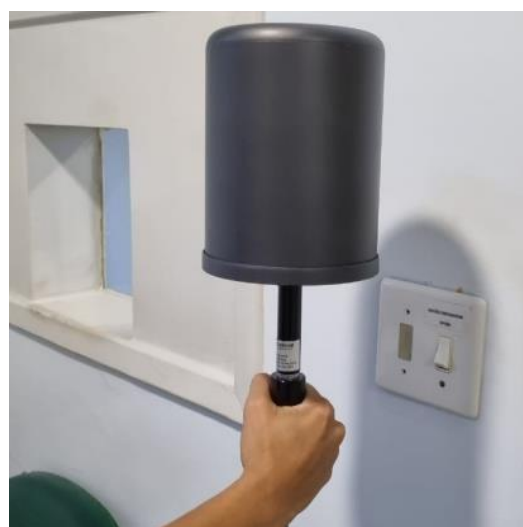
The radiometric survey was conducted using a Radcal 9095 electrometer and an 1800 cm³ ionization chamber, model 10X6-1800 (Figure 5). Measurements were taken at the points indicated in the room diagram (Figure 6). The areas that were analyzed were those surrounding the exam room. The measurements were made in places where there is a greater presence of people. Points A, B and C refer to the control room, where the exam is performed. Point D refers to the dental office that is located next to the exam room (point E).

Figure 5: Ionization chamber positioned to perform the radiometric survey

The radiometric survey was done using the parameters that produce the highest dose. It was also considered a workload of 50 weeks per year. The limits established at IN 94 [17], for free areas are 0.5 mSv/year, while at controlled areas are 5 mSv/year. The results showed that the calculated value was below those limits, showing that the wall's shielding is protecting the external areas from unacceptable dose rate levels. All measurements performed at each monitored point were satisfactory, demonstrating that the shielding is within the established limits.
